Manhole Inspection Summary

Manhole # S43A__029MH

Insp Date: **3/1/08 2:27 PM**

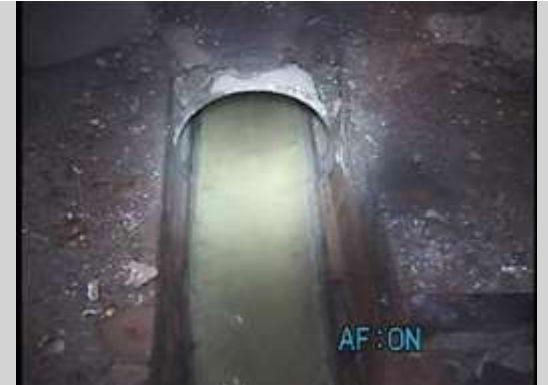
12 O'Clock Outflow

10 in. Circular Gravity Sewer
Pipe Out @ 12 O'Clock

Pipe Height: **10.8** (in.) Rod and Bar (Angled)
Pipe Material: **Clay** ☐ Pipe Lined
Invert Depth: **13.00** (ft.) Flow Characteristics: **Slow**
Deposits: ☒ None ☐ Mud ☐ Sludge ☐ Debris ☐ Grease
Silt Depth: (in.) Deposits Extent:
Infiltration: **None** Pipe Seal Cond: **Sound**

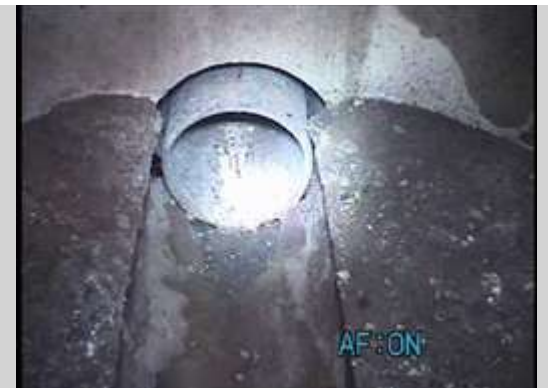
3 O'Clock Inflow

10 in. Circular Gravity Sewer
Pipe In @ 3 O'Clock

Pipe Height: **10.8** (in.) Rod and Bar (Angled)
Pipe Material: **Clay** ☐ Pipe Lined
Invert Depth: **12.80** (ft.) Flow Characteristics: **None**
Deposits: ☒ None ☐ Mud ☐ Sludge ☐ Debris ☐ Grease
Silt Depth: (in.) Deposits Extent:
Infiltration: **None** Pipe Seal Cond: **Sound**

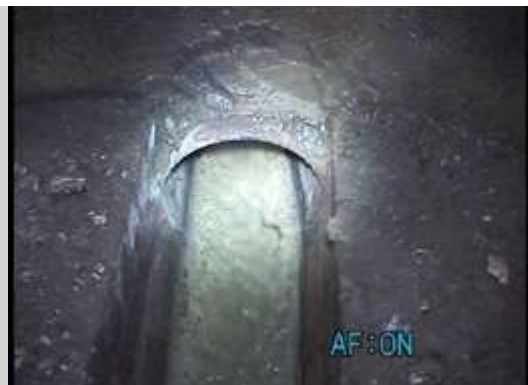
6 O'Clock Inflow

10 in. Circular Gravity Sewer
Pipe In @ 6 O'Clock

Pipe Material: **Clay** ☐ Pipe Lined

Invert Depth: **13.10** (ft.) Flow Characteristics: **Slow**

Infiltration: **None**

Pipe Seal Cond: **Sound**
